June 28, 2019
File No. 262018.063

Subject: Department of Natural Resources Washington Geological Survey,
School Seismic Safety Assessment Project, Contract No. AE 410 -
Seismic Evaluation for **Battle Ground School District**

School Buildings Evaluated in the Battle Ground School District

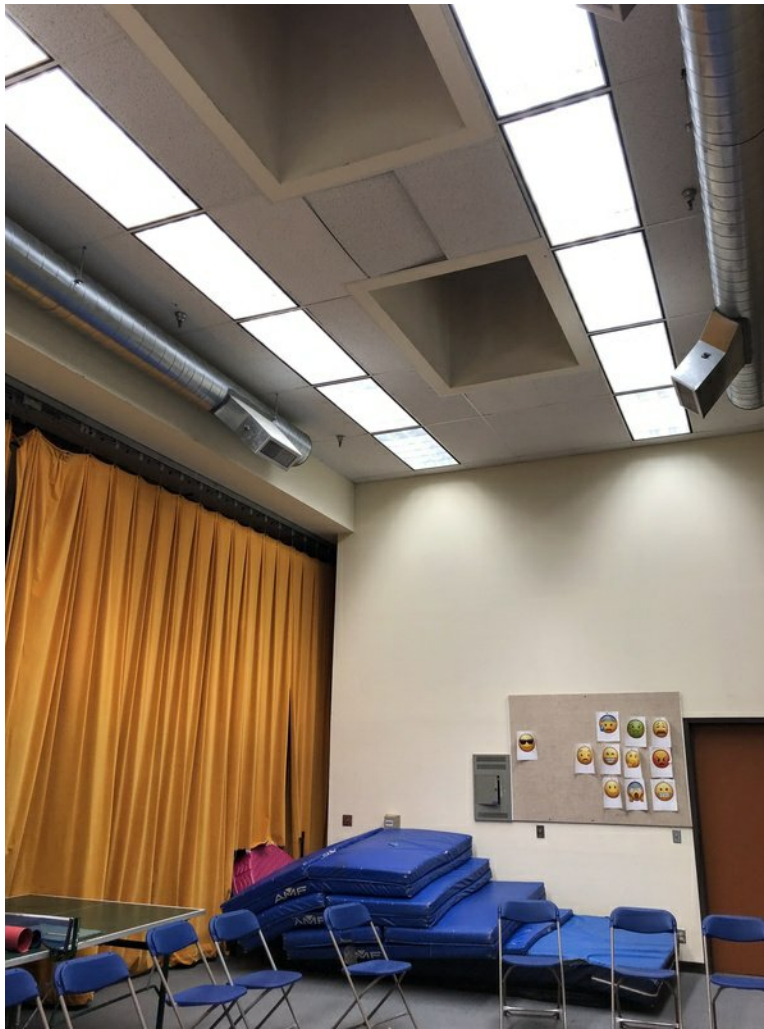
Deficiency	Description
LSS-3 Emergency Power. HR-not required; LS-LMH; PR-LMH.	Inadequate anchoring/bracing of life-safety equipment. All life-safety equipment should be anchored or braced to the structure.
LSS-5 Sprinkler Ceiling Clearance. HR-not required; LS-MH; PR-MH.	Inadequate penetration clearances at panelized ceilings for fire suppression devices. Provide clearance around sprinkler head or provide flexible lines between horizontal piping and sprinkler heads.
CF-2 Tall Narrow Contents. HR-not required; LS-H; PR-MH.	Anchorage is required for tall narrow contents more than six feet high to provide overturning restraint.

Figure 1-6. Inadequate Fire Sprinkler Penetration Clearance in Classroom

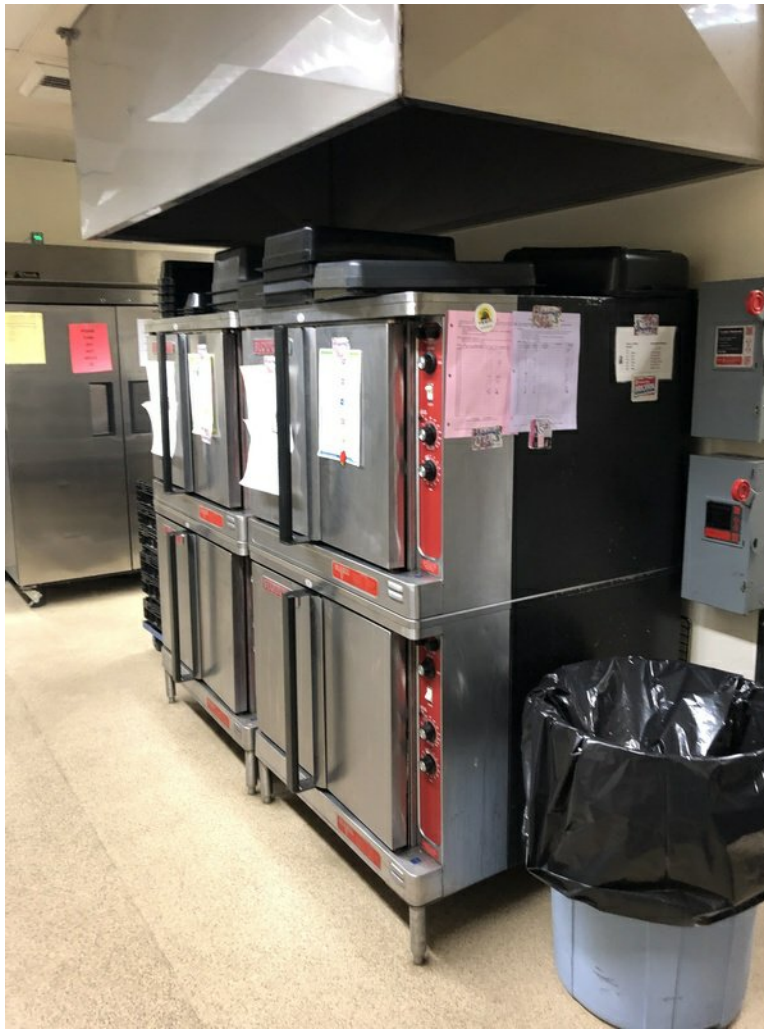
Figure 1-6. Unanchored Nonstructural Components in Kitchen

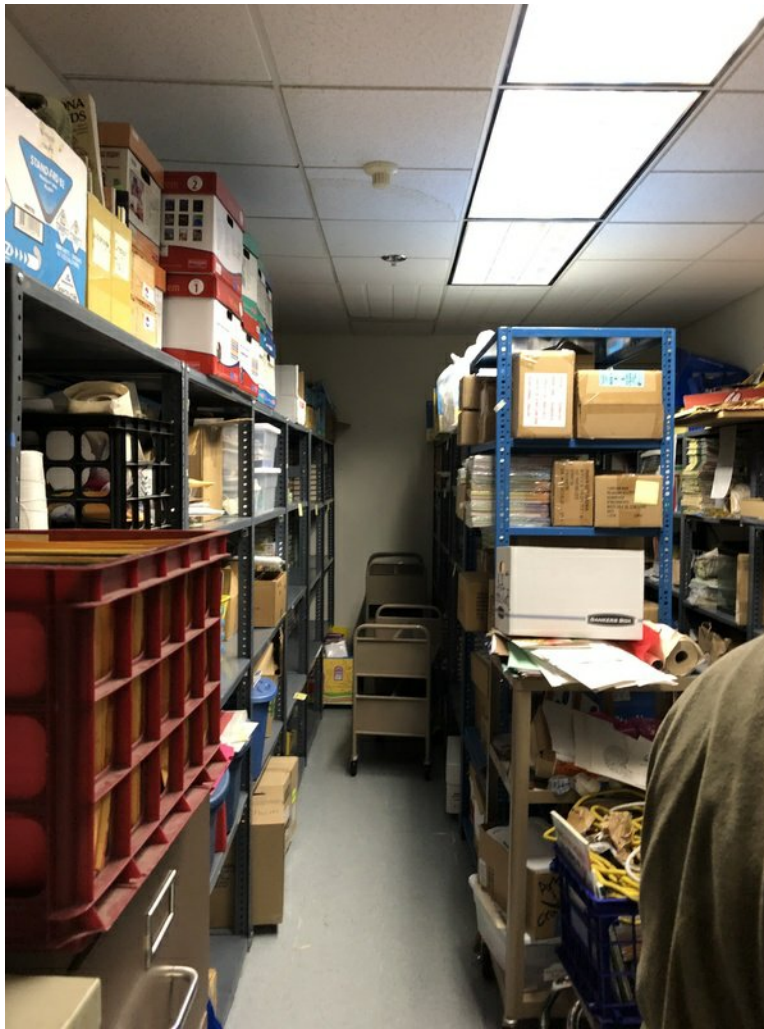
Figure 1-7. Unanchored Shelving and Storage

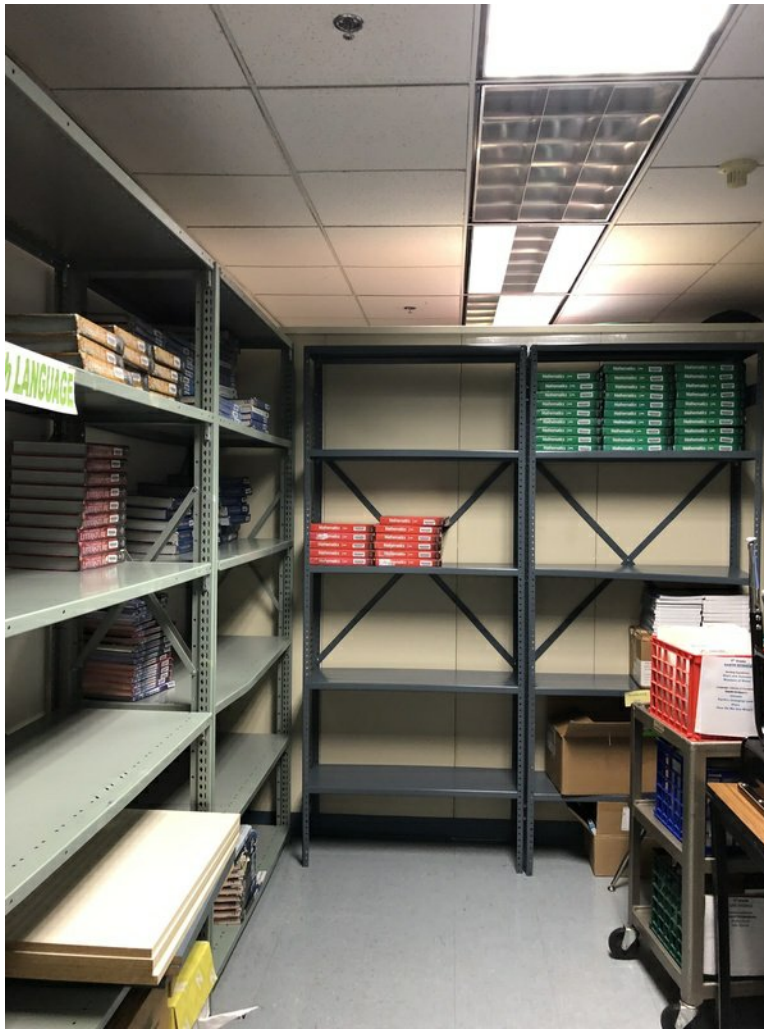
Figure 1-8. Unanchored Shelving and Storage

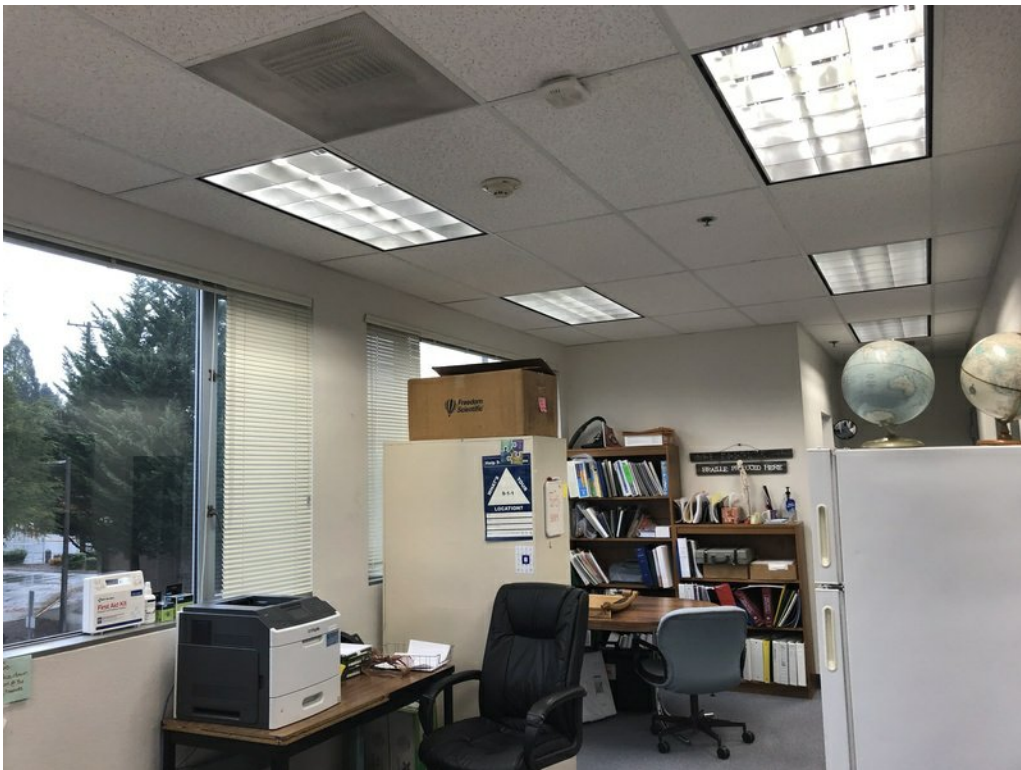
Figure 1-7. Office with Unbraced Tall, Narrow Contents

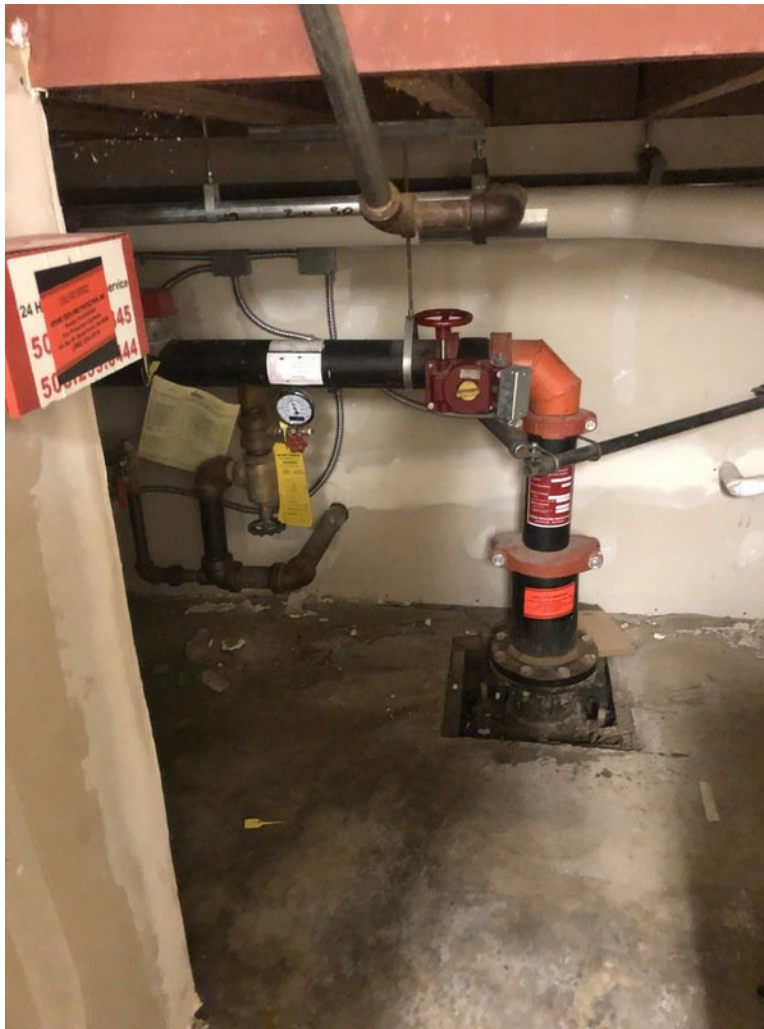
Figure 1-9. Fire Riser. Bracing of Fire Suppression Piping is Unknown.

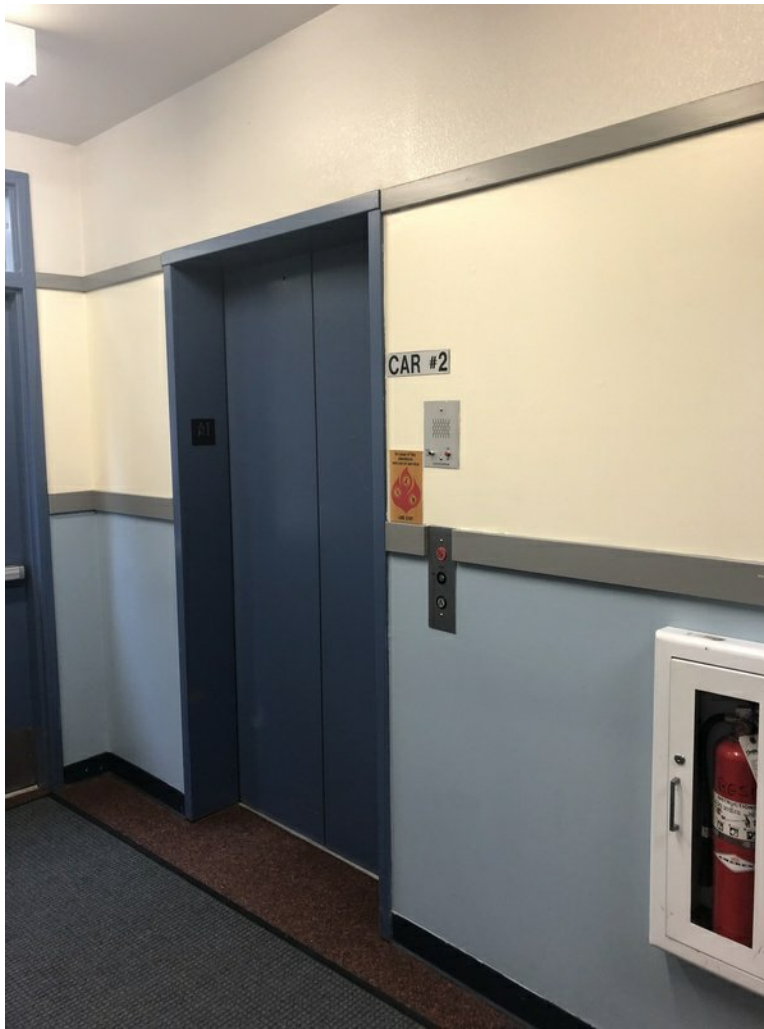
Figure 1-10. Elevator with Unknown Detailing

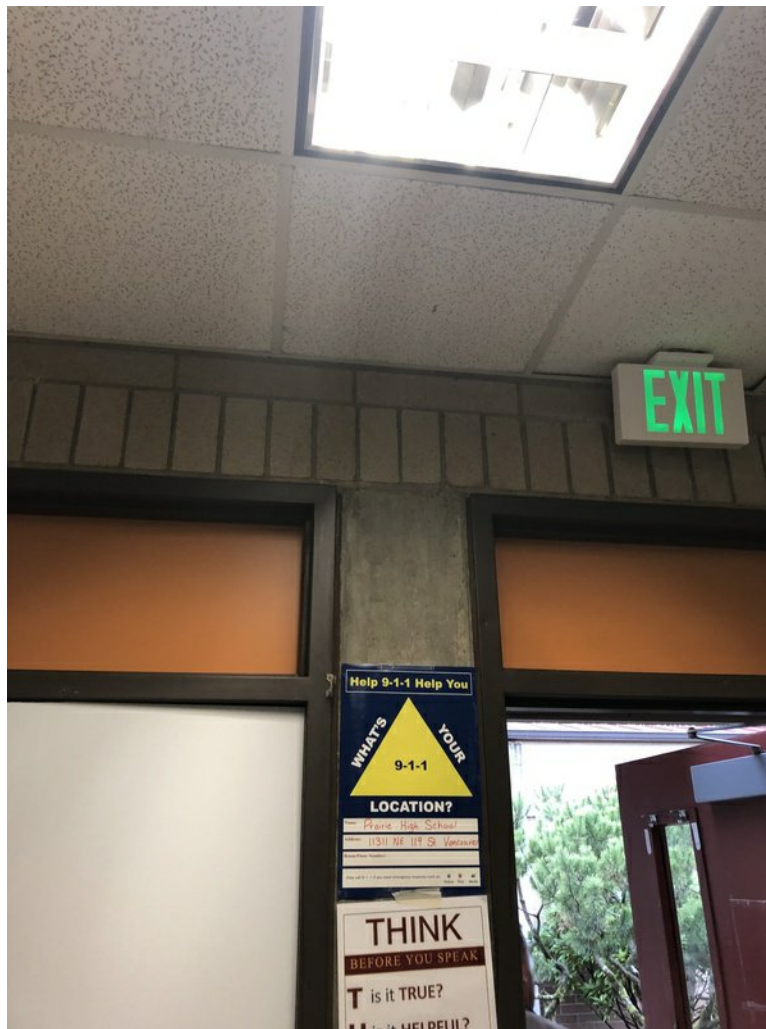
Figure 1-6. Masonry over Precast Column at Interior

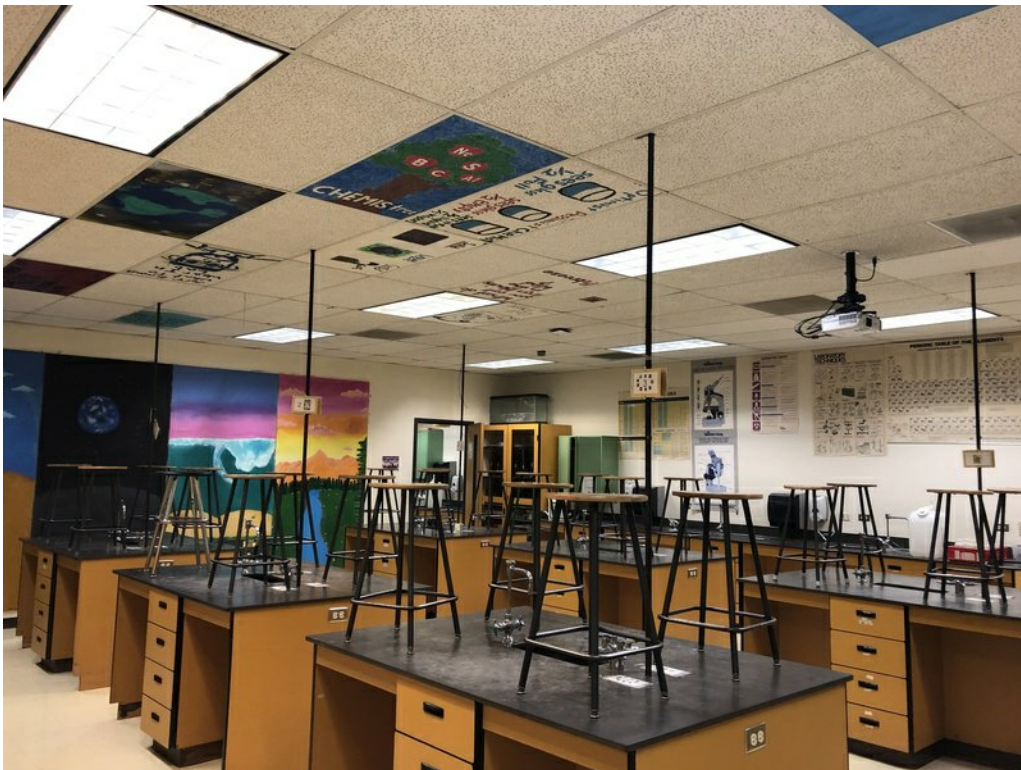
Figure 1-6. Science Classroom

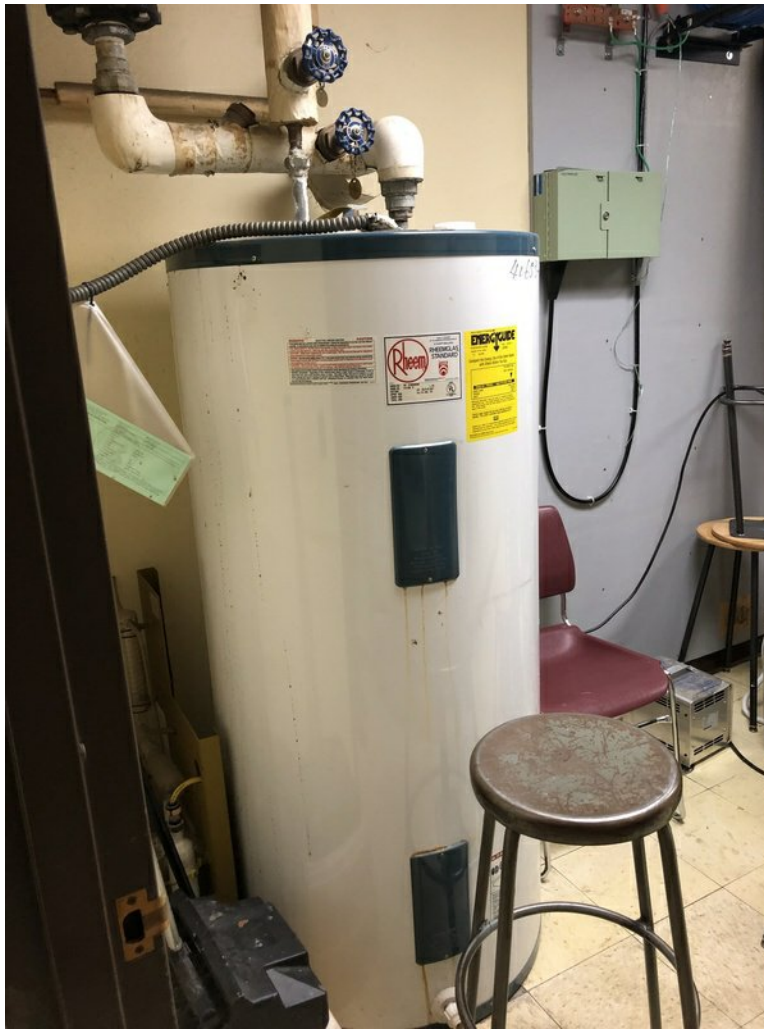
Figure 1-7. Mechanical Equipment, Typical

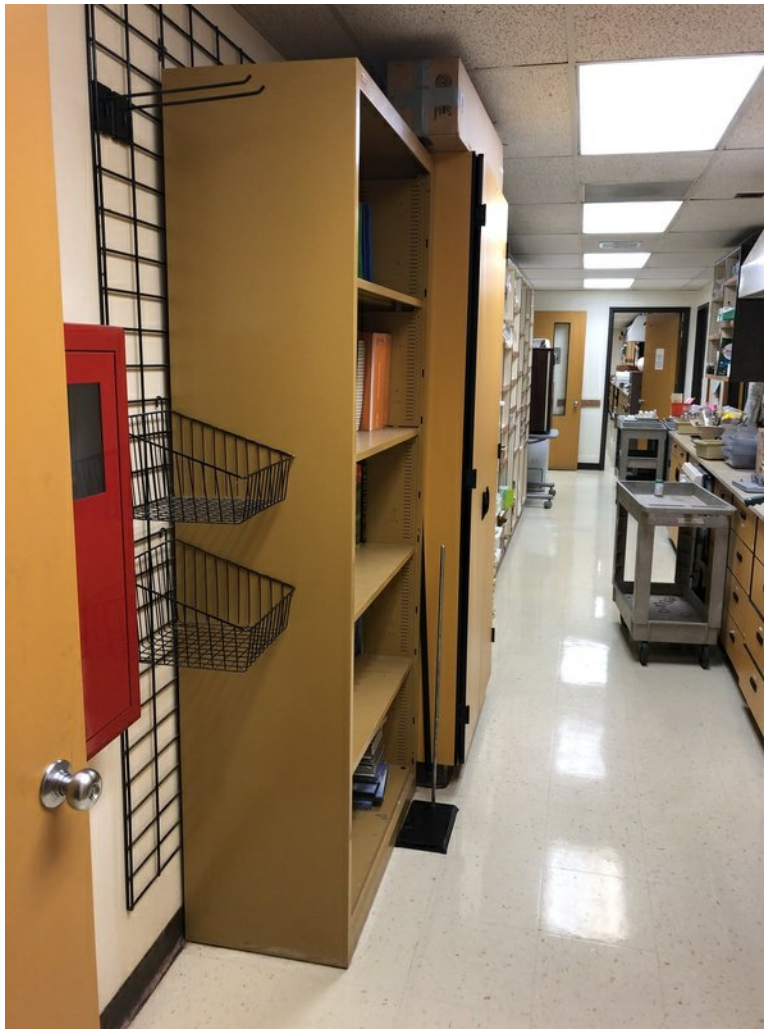
Figure 1-8. Unbraced Tall Narrow Contents, Typical

EVALUATION ITEM	EVALUATION STATEMENT	C	NC	N/A	U	COMMENT
ME-1 Fall-Prone Equipment. HR-not required; LS-H; PR-H.	Equipment weighing more than 20 lb (9.1 kg) whose center of mass is more than 4 ft (1.2 m) above the adjacent floor level, and which is not in-line equipment, is braced. (Tier 2: Sec. 13.7.1 13.7.7; Commentary: Sec. A.7.12.4)			X		None observed.
ME-2 In-Line Equipment. HR-not required; LS-H; PR-H.	Equipment installed in line with a duct or piping system, with an operating weight more than 75 lb (34.0 kg), is supported and laterally braced independent of the duct or piping system. (Tier 2: Sec. 13.7.1; Commentary: Sec. A.7.12.5)				X	Further investigation is required to review vertical support and lateral bracing of equipment.
ME-3 Tall Narrow Equipment. HR-not required; LS-H; PR-MH.	Equipment more than 6 ft (1.8 m) high with a height-to-depth or height-to-width ratio greater than 3-to-1 is anchored to the floor slab or adjacent structural walls. (Tier 2: Sec. 13.7.1 13.7.7; Commentary: Sec. A.7.12.6)		X			Anchorage is required for tall narrow equipment more than six feet high to provide overturning restraint.

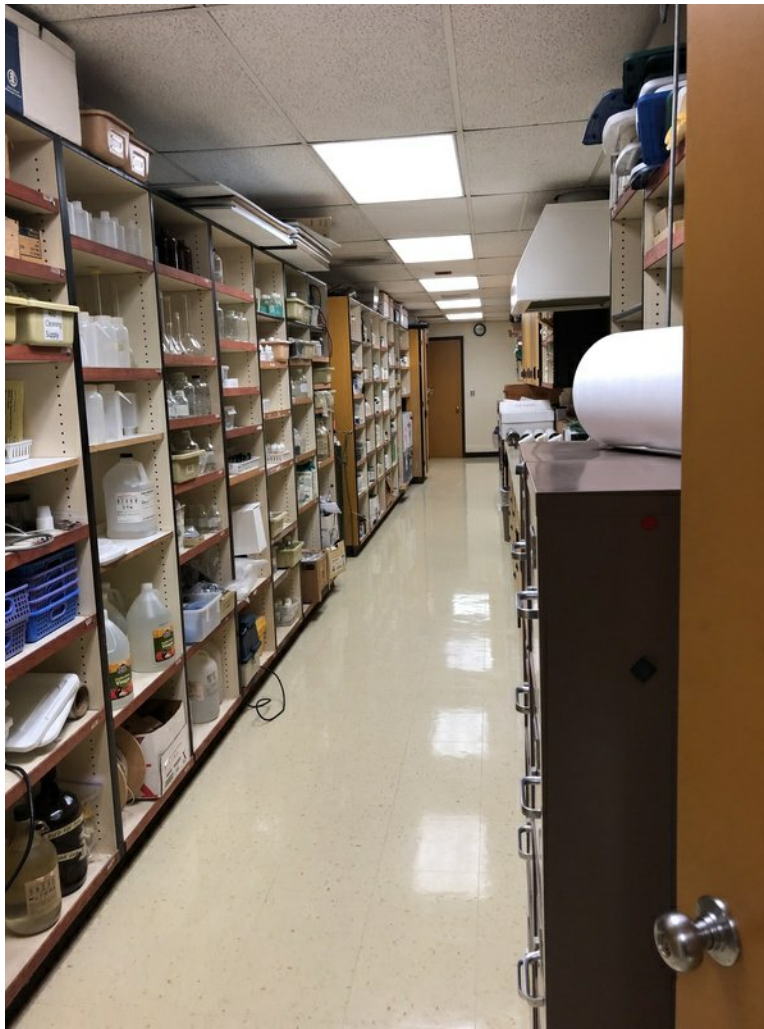
Figure 1-9. Unrestrained Breakable Containers, Typical

EVALUATION ITEM	EVALUATION STATEMENT	C	NC	N/A	U	COMMENT
HM-1 Hazardous Material Equipment. HR-LMH; LS-LMH; PR-LMH.	Equipment mounted on vibration isolators and containing hazardous material is equipped with restraints or snubbers. (Tier 2: Sec. 13.7.1; Commentary: Sec. A.7.12.2)			X		
HM-2 Hazardous Material Storage. HR-LMH; LS-LMH; PR-LMH.	Breakable containers that hold hazardous material, including gas cylinders, are restrained by latched doors, shelf lips, wires, or other methods. (Tier 2: Sec. 13.8.3; Commentary: Sec. A.7.15.1)		X			Science supplies. Inadequate restraints for breakable containers storing hazardous material. Provide latched doors, shelf lips, or wires.

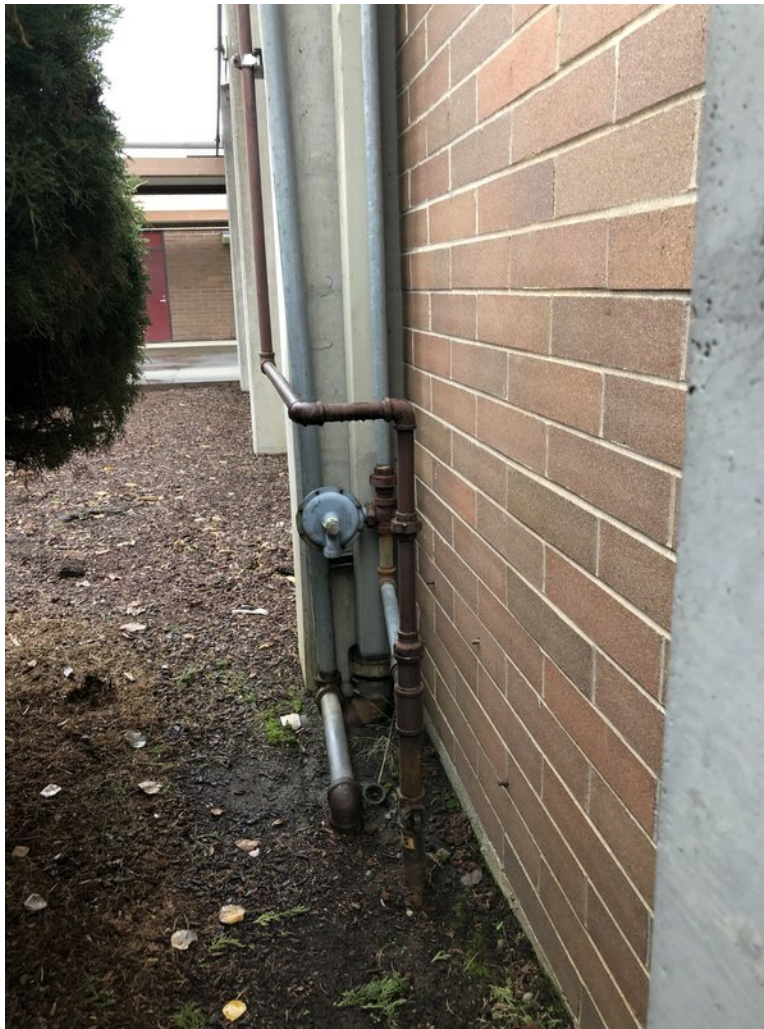
Figure 1-10. Natural Gas without Shutoff Valve

HM-3 Hazardous Material Distribution. HR-MH; LS-MH; PR-MH.	Piping or ductwork conveying hazardous materials is braced or otherwise protected from damage that would allow hazardous material release. (Tier 2: Sec. 13.7.3, 13.7.5; Commentary: Sec. A.7.13.4)		X			Natural gas. Piping/ductwork not adequately protected from damage that could potentially allow release of hazardous material. Natural gas piping should be adequately braced to the structure.
HM-4 Shutoff Valves. HR-MH; LS-MH; PR-MH.	Piping containing hazardous material, including natural gas, has shutoff valves or other devices to limit spills or leaks. (Tier 2: Sec. 13.7.3, 13.7.5; Commentary: Sec. A.7.13.3)		X			None observed. Insufficient protection (shutoff valves or other devices) to limit spills/leaks from piping containing hazardous materials. Installation of shutoff valves may be appropriate to limit hazardous material spills.

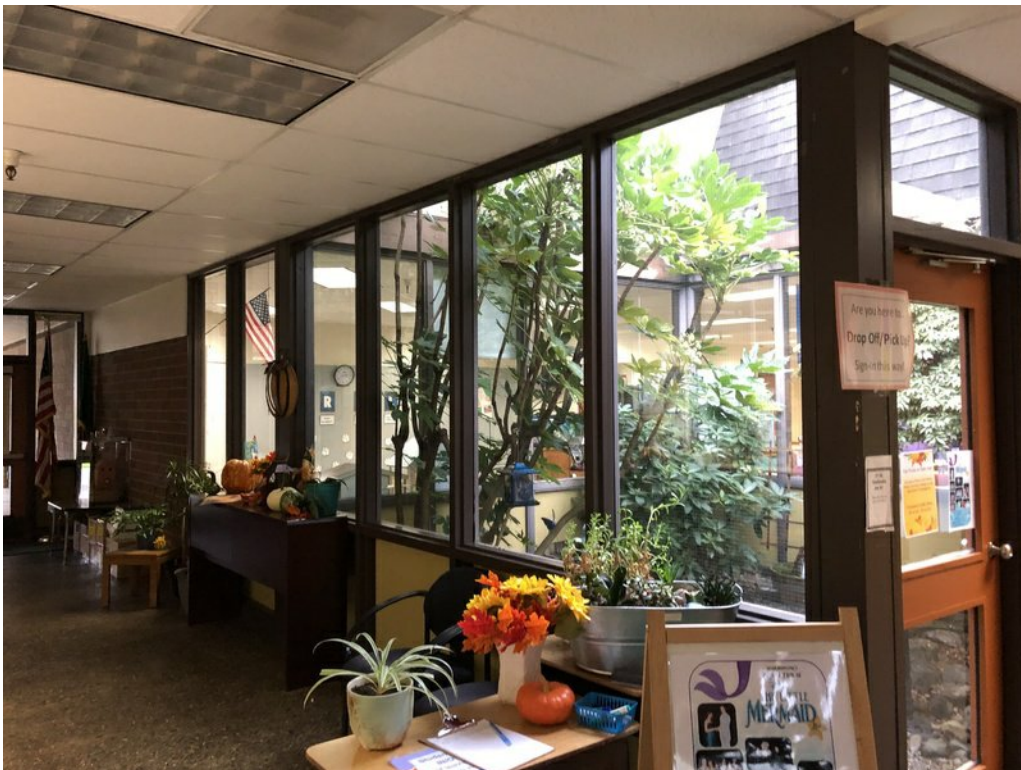
Figure 1-7. Wood Truss Roof

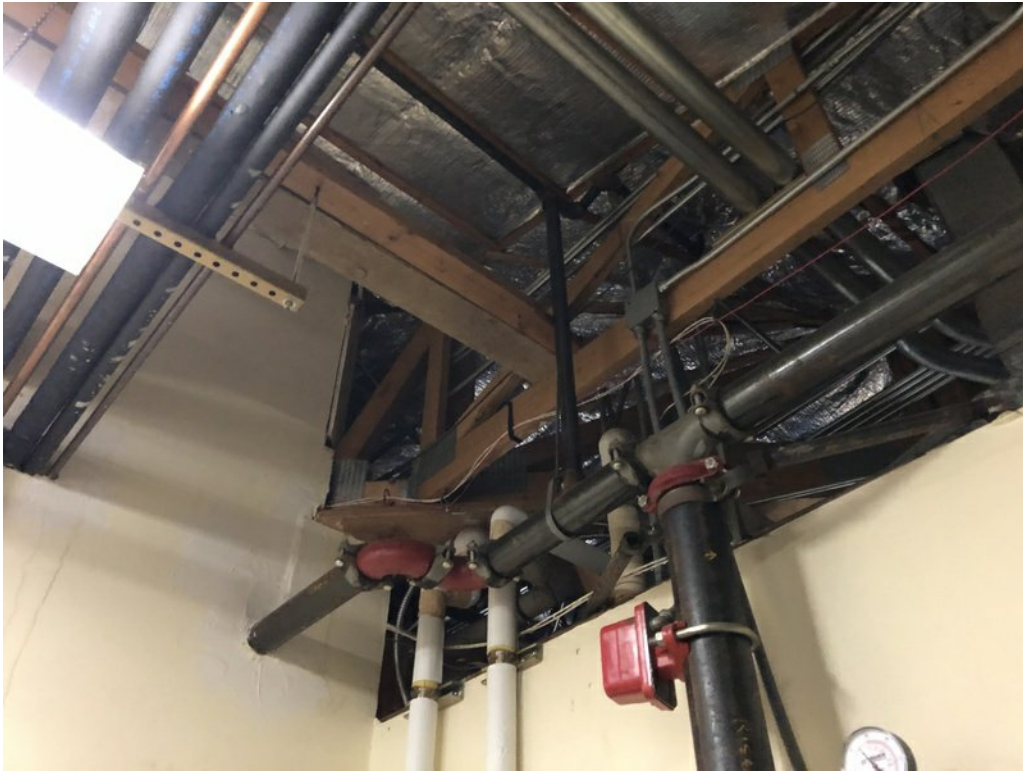
Figure 1-8. Mechanical Room with Unbraced Piping

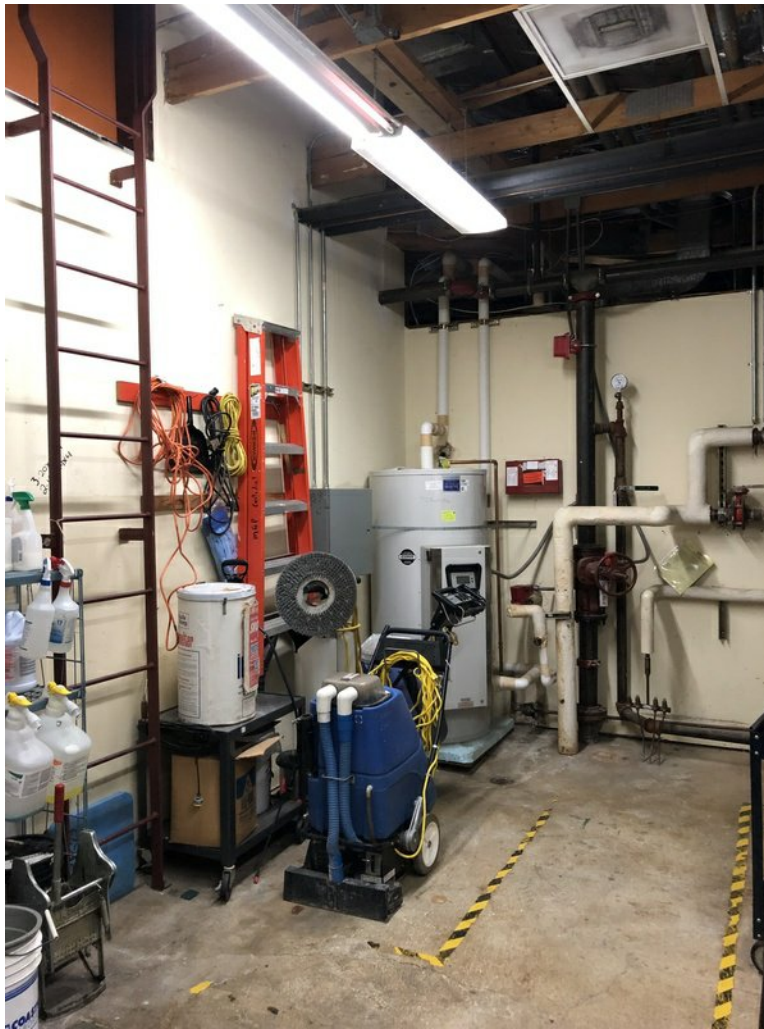
Figure 1-9. Storage Room with Unbraced Tall Narrow Contents

ME-1 Fall-Prone Equipment. HR-not required; LS-H; PR-H.	Further investigation is required to review the anchorage of fall-prone equipment.
ME-2 In-Line Equipment. HR-not required; LS-H; PR-H.	Further investigation is required to review the vertical support and lateral bracing of equipment.
ME-3 Tall Narrow Equipment. HR-not required; LS-H; PR-MH.	Further investigation is required to review the anchorage of tall narrow equipment.
